USAAEFA PROJECT NO. 83-22

LIMITED ARTIFICIAL AND NATURAL ICING TESTS OF THE EXTERNAL STORES SUPPORT SYSTEM (ESSS) INSTALLED ON A UH - 60A AIRCRAFT

JUNE 1984 FINAL REPORT

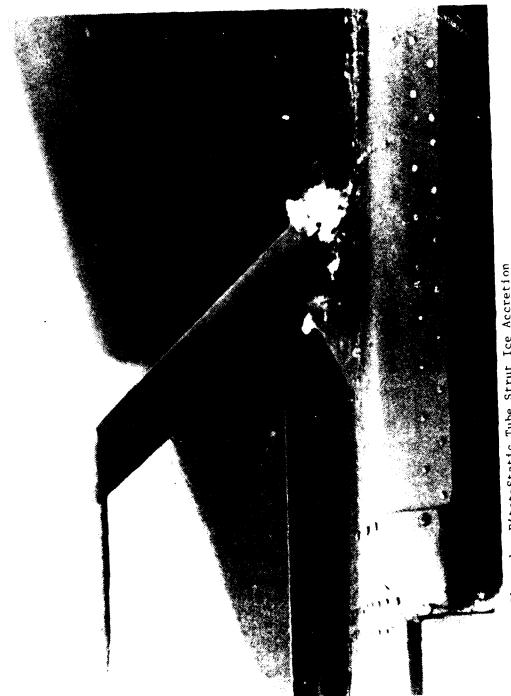
10. Pitot-static tube strut anti-ice characteristics were evaluated throughout these tests. Specific test conditions are presented in table 1, appendix F. The test aircraft was equipped with the improved airspeed system (para 7, app B). The pitotstatic tube is fully anti-iced, while only the leading edge of the support strut is anti-iced. The improved airspeed system was tested with an aerodynamic fairing and with wedges installed (photos 7 and 8, app B). Large ice accretions were observed to form on the unheated aft, outboard, lower portions of both pitotstatic tube struts at most of the conditions tested (artificial and natural). An example of these ice formations is shown in photo 1, appendix G. These ice accretions were larger with increased icing exposure (liquid water content (LWC) or time) and were characterized by clear globular formations. characteristics are typical of runback ice formations indicating that the pitot-static tube strut anti-ice capabilities were exceeded. The location of the ice formation, directly in front of the engine inlet, increases the probability of engine FOD, although none was noted during 23.6 hours of icing condition flight. Since previous testing on UH-60 aircraft without the improved airspeed system installation fairing or wedge did not encounter this problem, it is expected that the size and shape of the improved airspeed system installation fairing or wedge was responsible for these ice formations. The inadequate anti-ice provisions on the pitot-static tube support struts as installed with the improved airspeed system fairings or wedges is a shortcoming. The inadequate anti-ice capabilities of the pitot-static tube support struts should be improved prior to release into icing conditions of any UH-60 aircraft configured with the improved airspeed system.

- b. The large ice accretions on the forward portion of the improved airspeed system pitot-static tube support strut fairings or wedges (para 14).
- c. The inadequate anti-ice provisions on the pitot-static tube support struts as installed with the improved airspeed system fairings or wedges (para 10).

Photo 1. Pitot-Static Tube Strut Ice Accretion

Avg FAT - -7.0°C Avg IWC - 0.36 gm/m³ Time in Cloud - 168 minutes Configuration - 4-Tank Conditions: Environment - Natural Flight - 17

- 24. The shortcoming listed in paragraph 22a should be corrected prior to release of any UH-60 aircraft, equipped with a WSPS, to operate in icing conditions (para 18).
- 25. The shortcomings listed in paragraph 22b and c should be corrected prior to release into icing conditions of any UH-60 aircraft, equipped with the improved airspeed system pitot-static tube support strut fairings or wedges (paras 10 and 14).
- 26. The following recommendations still apply from previous UH-60 icing tests since no corrective action has been accomplished or the corrective action taken was inadequate to warrent deletion of the previous (refs 2 and 3, app A) recommendation (para 20).
- a. The Windshield Anti-Ice Copilot and Pilot switches should be labeled to indicate the reset feature of the OFF position.
- b. The following CAUTION should be placed in the operator's manual immediately:
